# **J M Judge & Associates Expert Report**

*3/4/2022*

*Hilltop Church of The  
Nazarene*

10818 University Blvd.

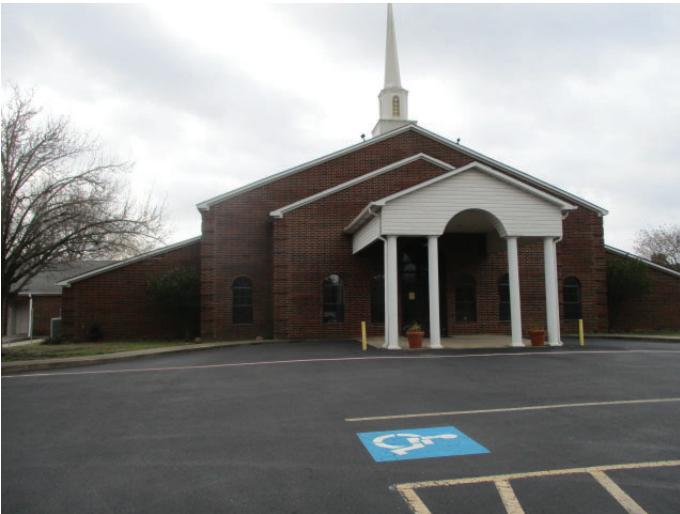
Overview

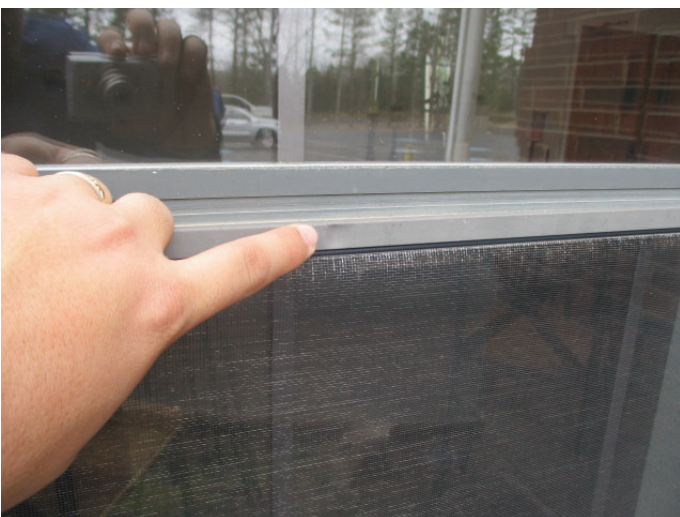
Impact Damage to Screen

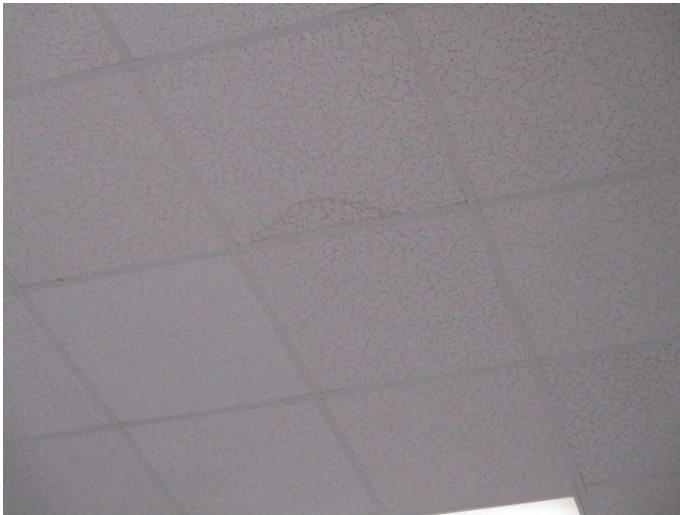
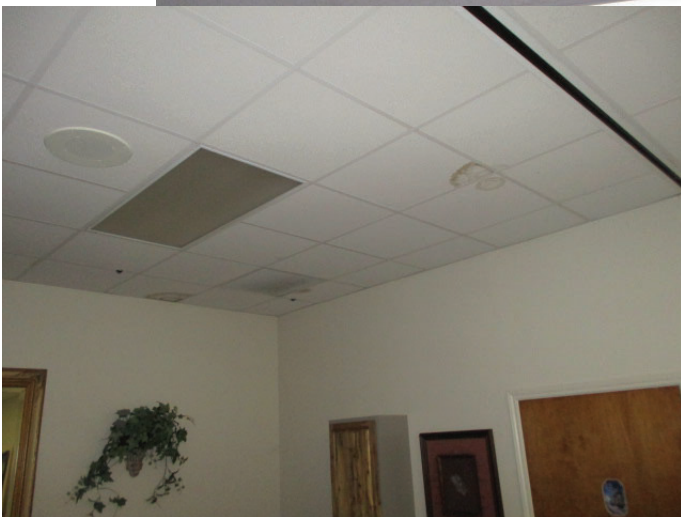
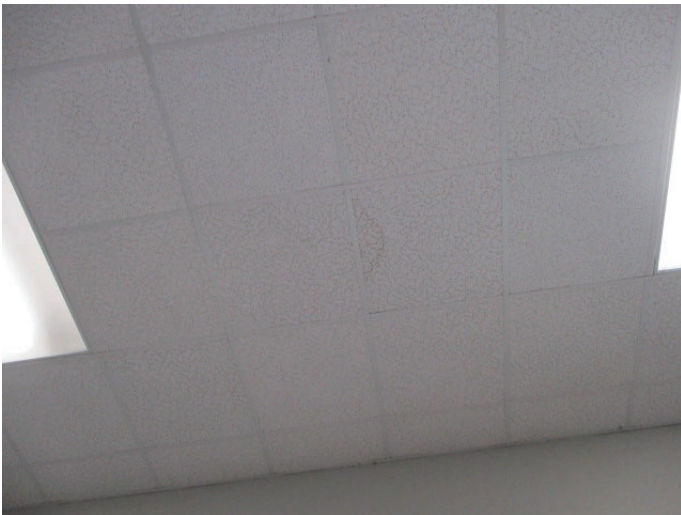
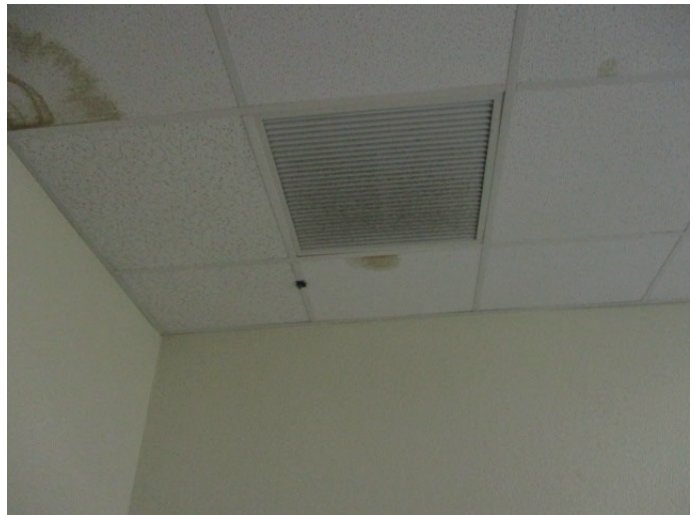
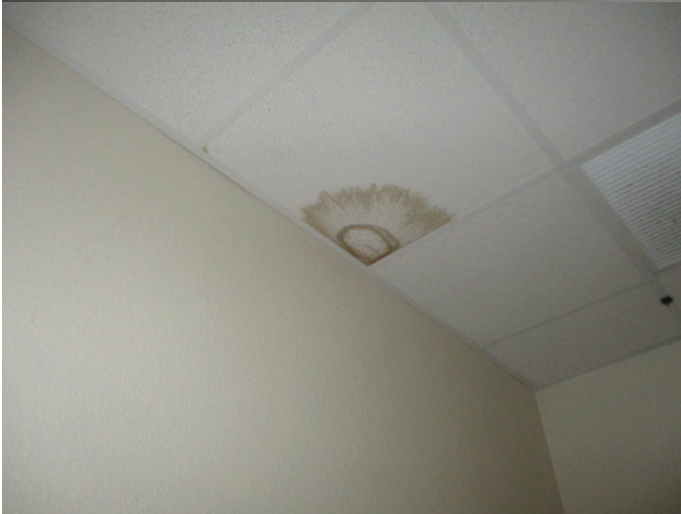
**Interior Evaluation:** Multiple ceiling stains throughout the building indicating multiple recent roof leaks.

# Sample of interior damage found:

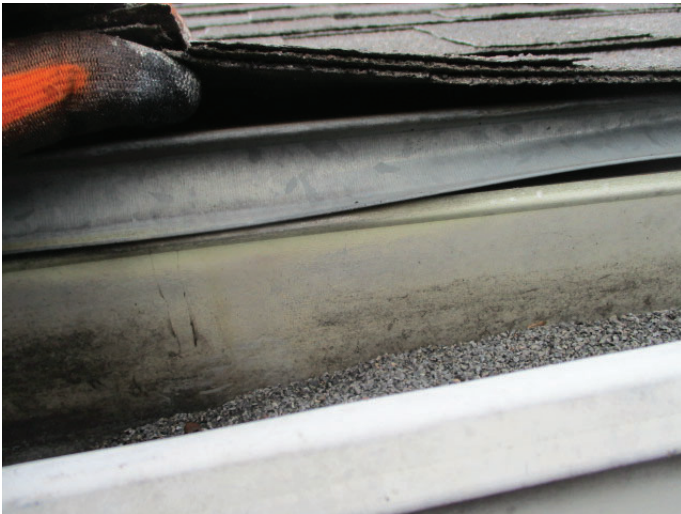
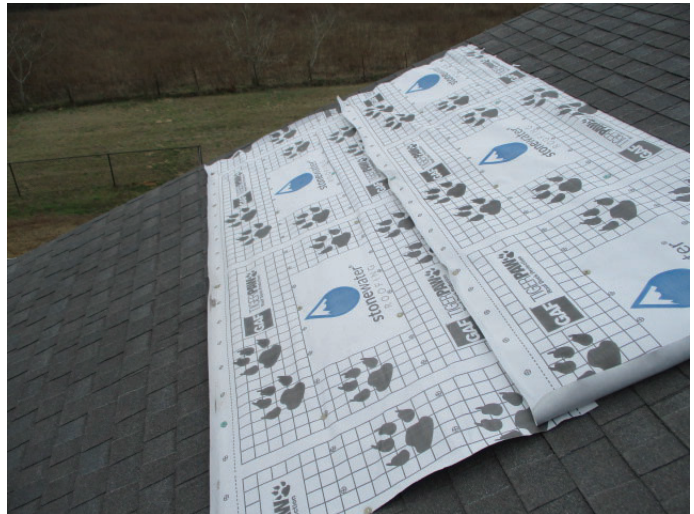
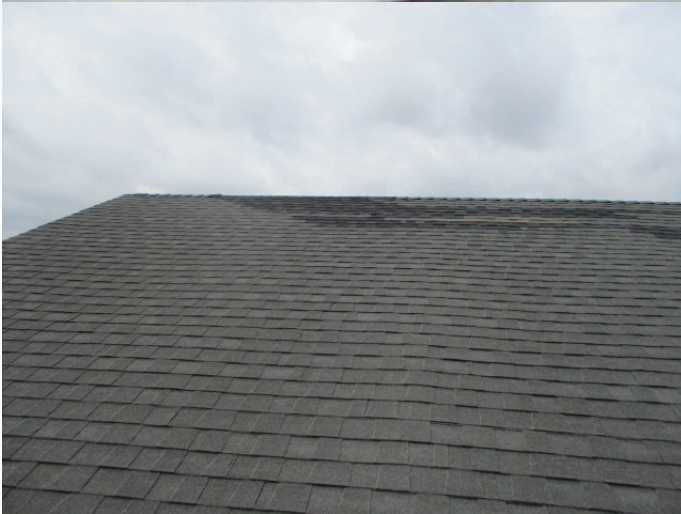
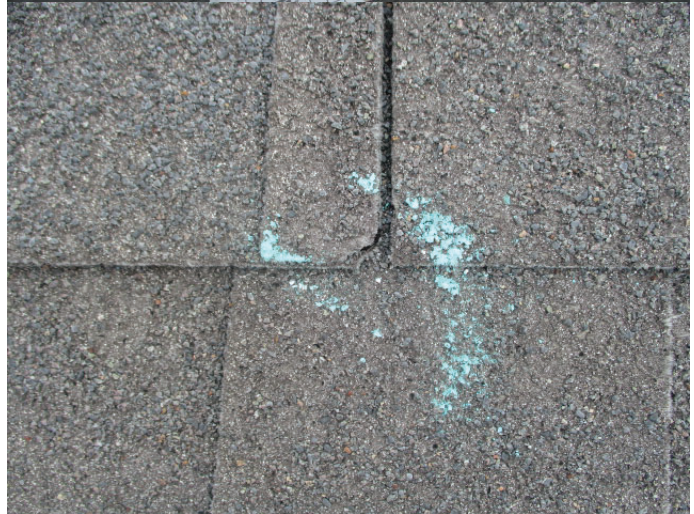
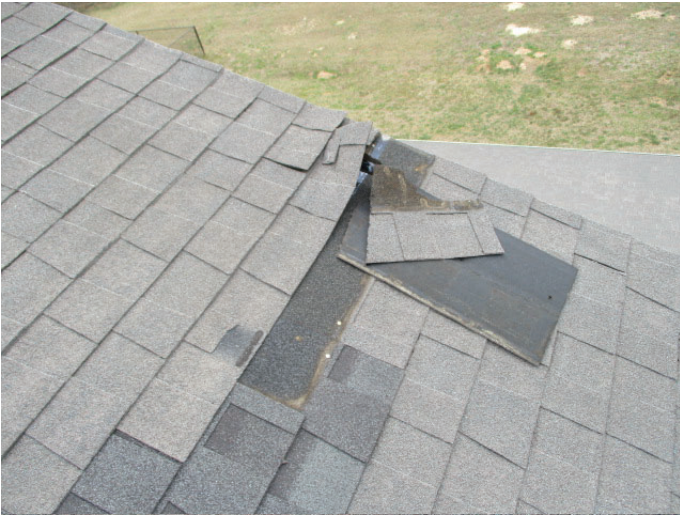
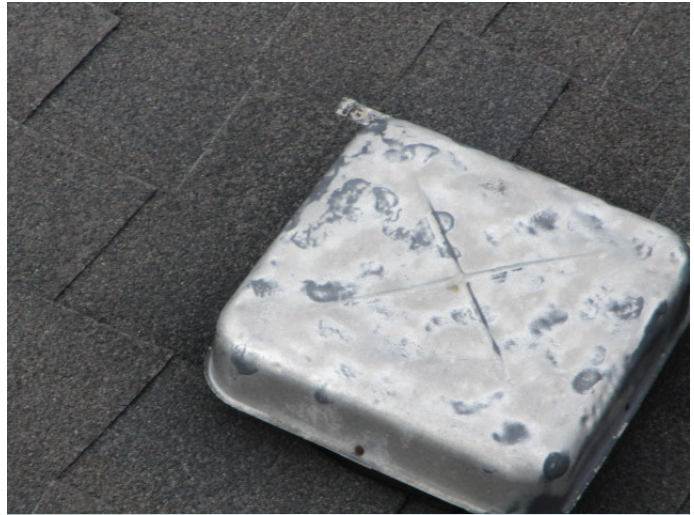
**Hail Evaluation:** Multiple recent hail penetrations consistent with the March 2019 storm event. These penetrations have damaged the Light Weight Laminate Roof system and allowed water to penetrate the roof covering. These storm created openings constitute functional damage and have shorthand life span of the roof covering and associated components.

**Hail Summary:** Hail has struck the entirety of the roof located at the address mentioned above and has damaged it to the point that it needs to be replaced, said damage has caused leaks allowing water marks and destruction to the interior.

# Sample of Roof Damage

Replacement; See estimate attached
